CHASES POND DAM
ME 00188

PHASE I INSPECTION REPORT
NATIONAL DAM INSPECTION PROGRAM

APRIL 1980

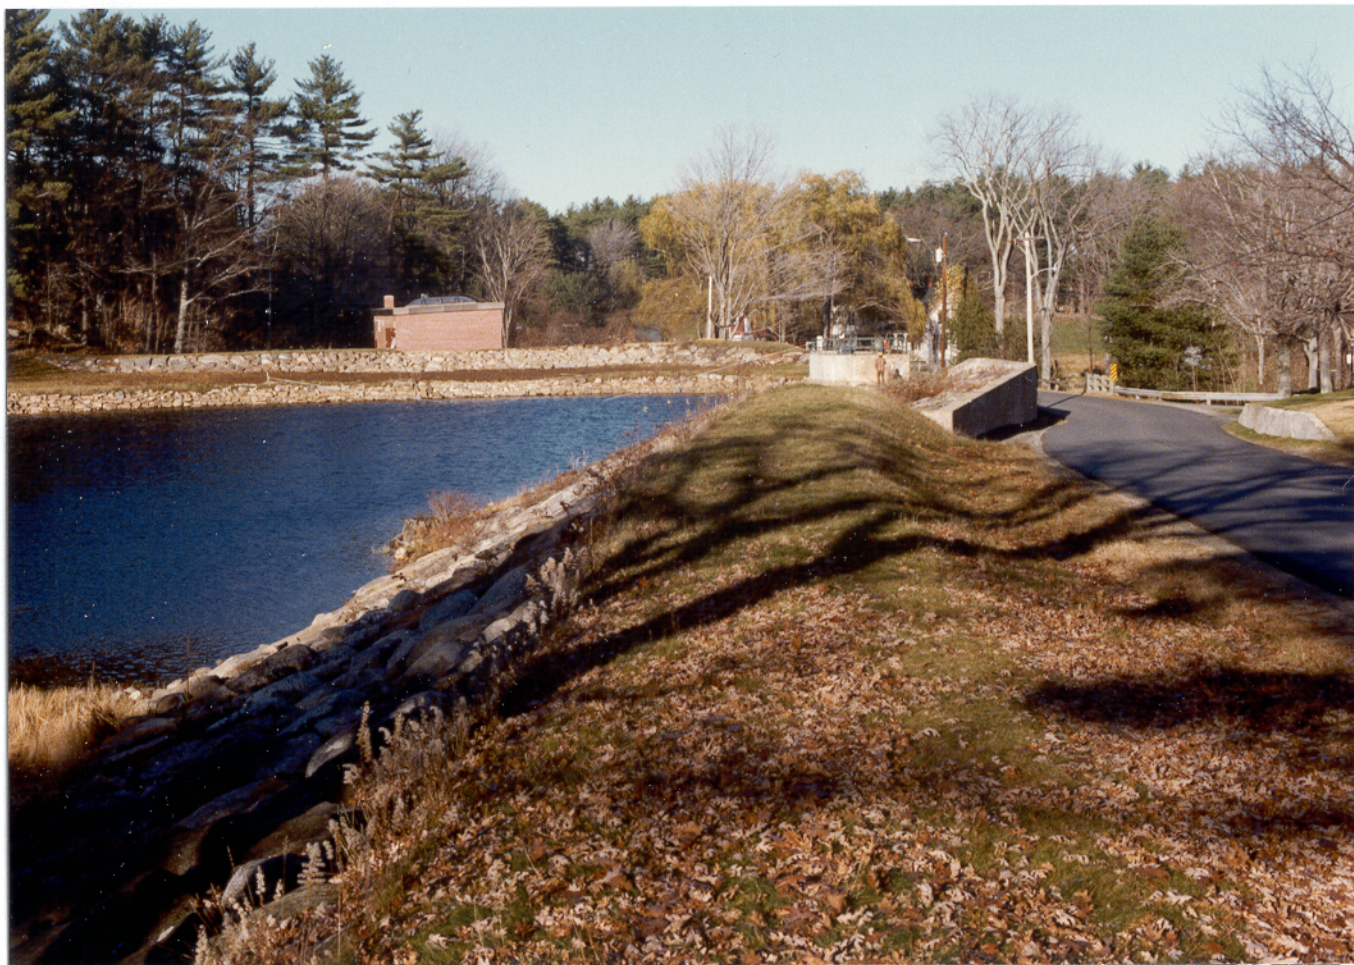
1. Overview of Chases Pond Dam showing upstream side

The top of the embankment is covered by mowed grass in excellent condition, Photo No. 1. The downstream slope is also covered by grass to the shoulder of the adjacent asphalt concrete for Chases Pond Road. The vertical and horizontal alignment of the embankment are good.

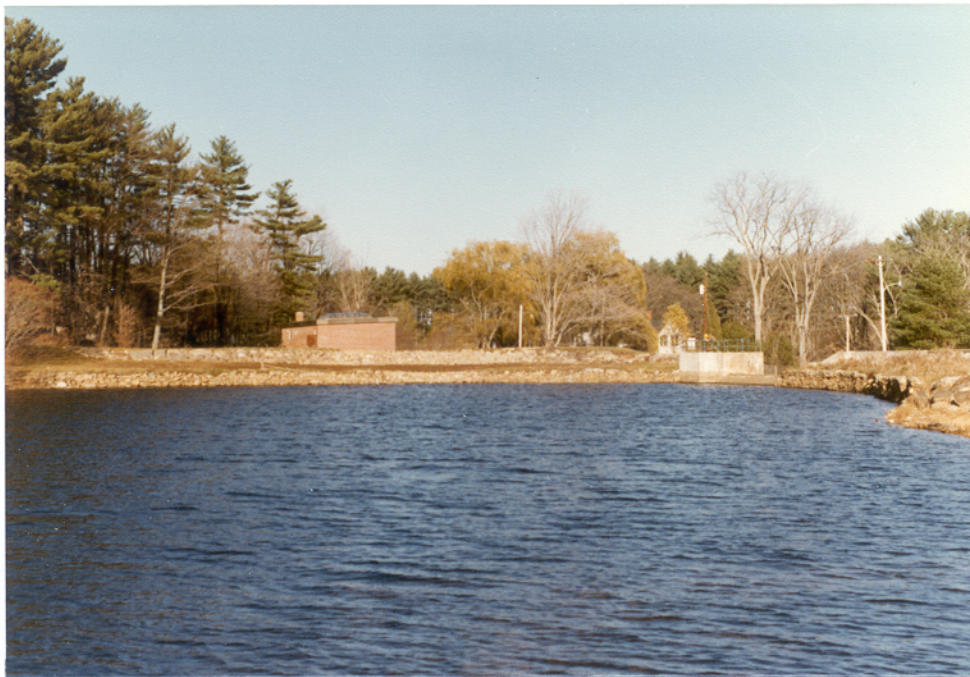
Reconstruction of the left embankment, Photo No. 2, following installation of the new (1979) intake pipe was not yet complete. The top surface had not been brought to the required grade, Photo No. 3, nor had the downstream slope been finally shaped, loamed and seeded. The condition of the earth material placed at this section was soft (following recent rains) and irregular.

2. Overview of left embankment, upstream

2. Monitor the condition of the left embankment in the area of 1979 excavation with attention to the development of any transverse cracks or irregular settlement. Observation of the conditions in this area should be maintained for the next two to three years, particularly during high reservoir levels.

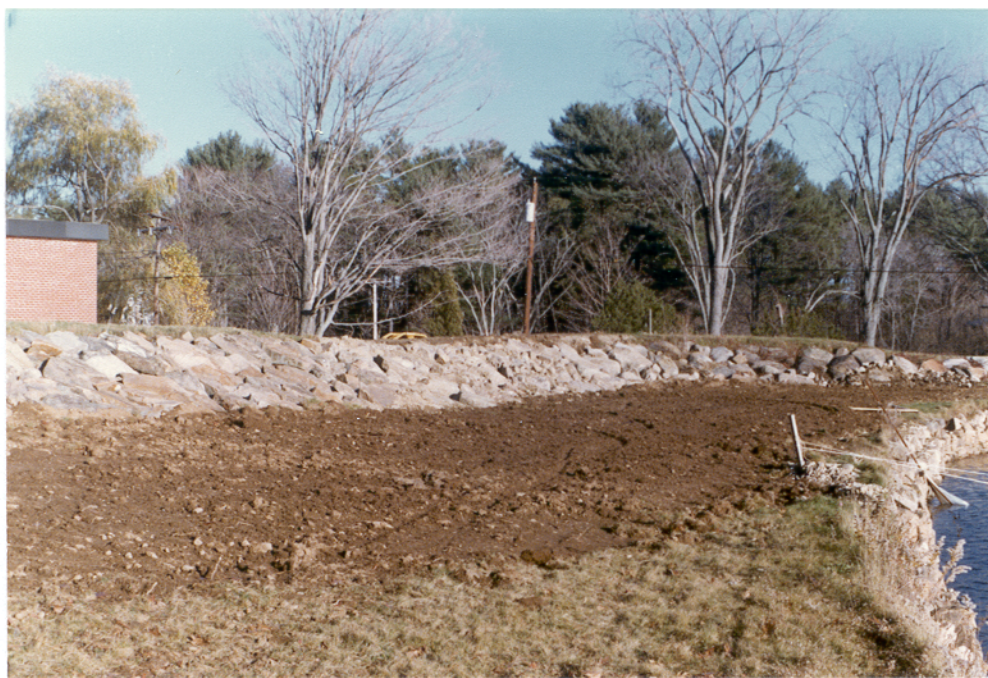
3. Left embankment at location of 1979 work

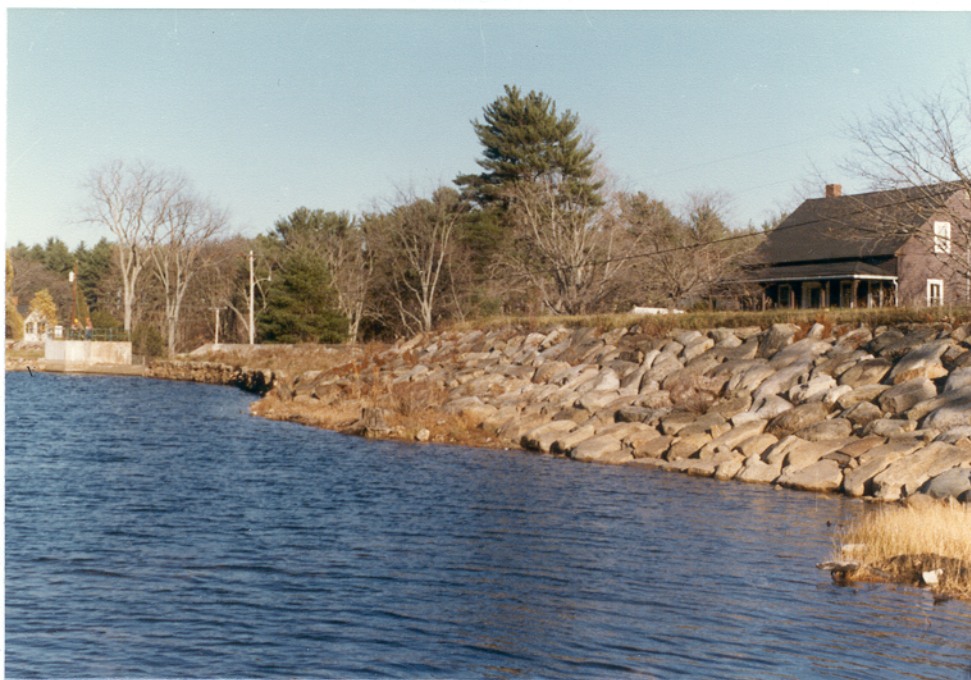
4. Overview of right embankment and cantilever wall, upstream

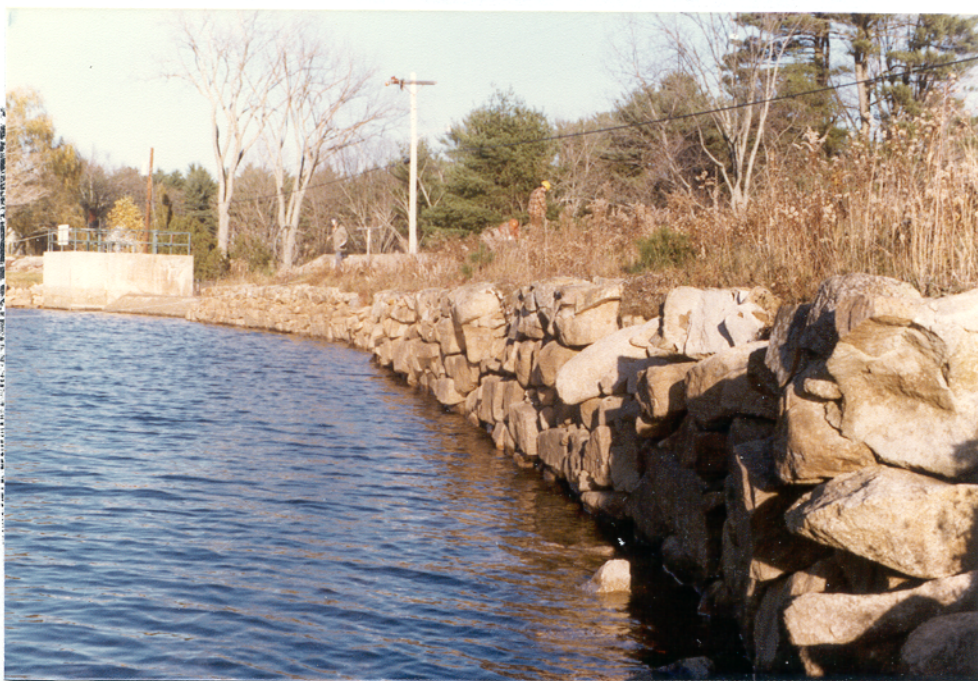
The upstream vertical stone wall at this section of the dam, Photo No. 5, is also in generally fair to poor condition. In several places, the stones have collapsed and in many areas they are out of alignment. Generally, the stone wall is in better condition within 50 ft. of the spillway.

5. Dry laid stone masonry along reservoir at right side

4. Rebuild the failed portions of the dry laid stone wall. A regular maintenance program to correct future localized failures of the stone wall should be developed.

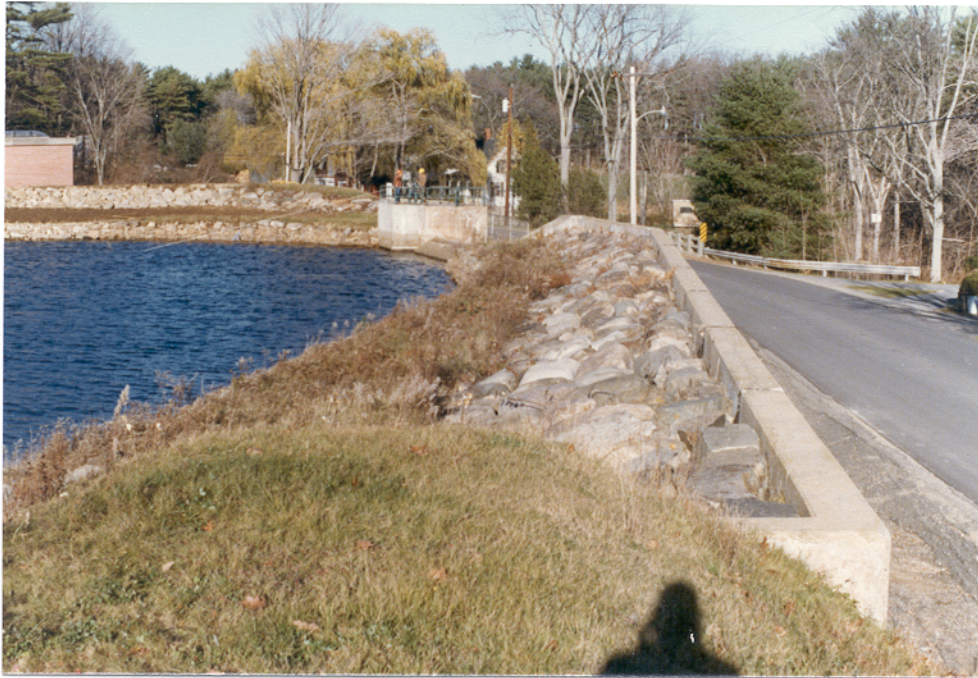
The right cantilever wall, Photo No. 10, evidences early signs of major deterioration of the concrete (see Appendix page A-5). Many of the wall panels have edge and joint deterioration, a longitudinal crack along the top surface of the wall, surface crazing of the concrete and/or efflorescence on the downstream face. The second panel from the spillway, Photo No. 11, appears to have shifted or tilted outward from the alignment of the adjacent wall panels. Other than the second panel, the alignment of the wall is good, Photo No. 6.

6. Alignment of right cantilever wall, spillway and left embankment

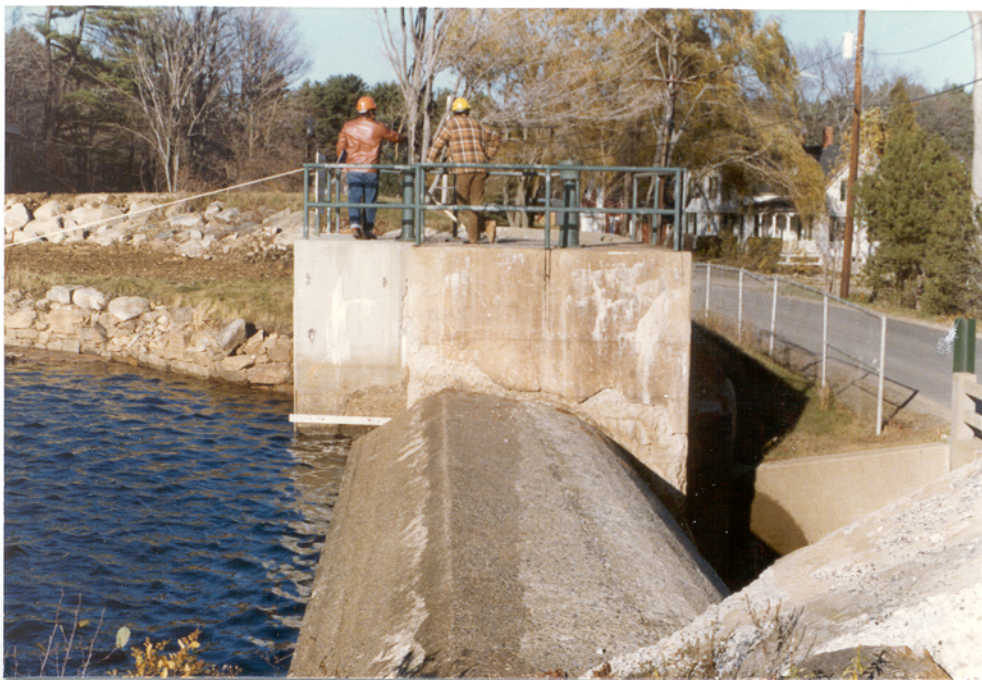
The top surface of the wall where it abuts the upstream side of the spillway is deteriorated, Photo No. 7. This low deteriorated area exposes the adjacent cantilever wall backfill to potential scouring during higher than normal discharges over the spillway.

7. Alignment of spillway/gate structure, from right side

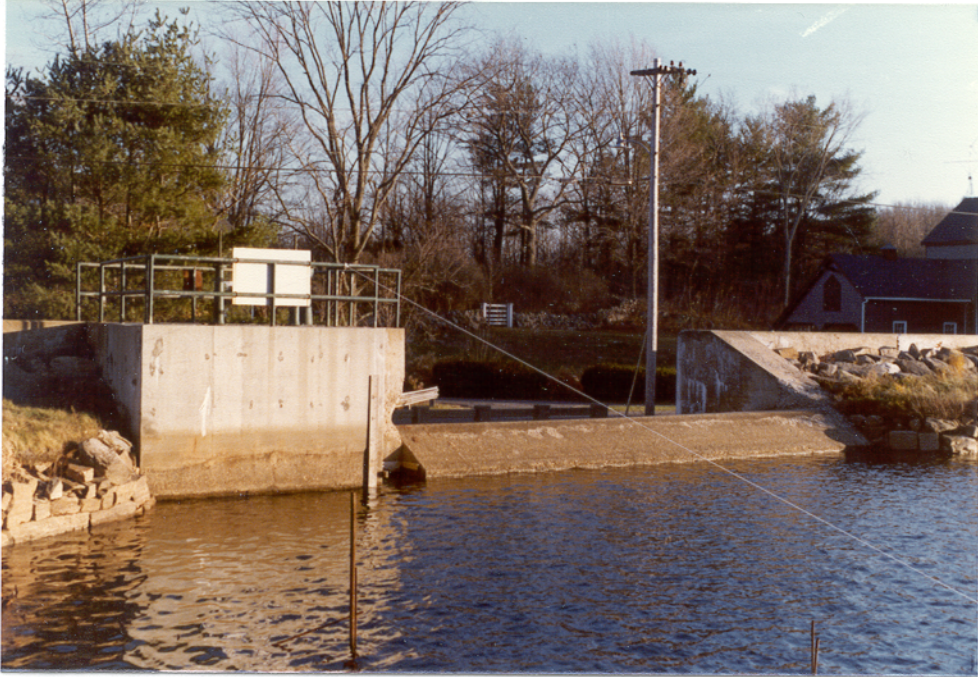
The spillway/gate structure, Photo No. 8, has a lightly eroded surface, but it does not appear to be of significance. There is a crack or opening near the spillway crest apparently where concrete placed for the 1950 reconstruction of the dam abuts the original concrete. Minor spalling, Photo No. 7, and areas of moisture were on the spillway surface but the conditions are not extensive. The upstream side of the intake or gate portion of the structure appeared to be a more recent placement of concrete and was in good condition. The downstream side of the structure, especially the lower regions, showed efflorescence, spalling, some cracking and general surface deterioration.

8. Spillway/gate structure, upstream

2. Determine the depth of surface deterioration of concrete elements and the necessity and means of repair.

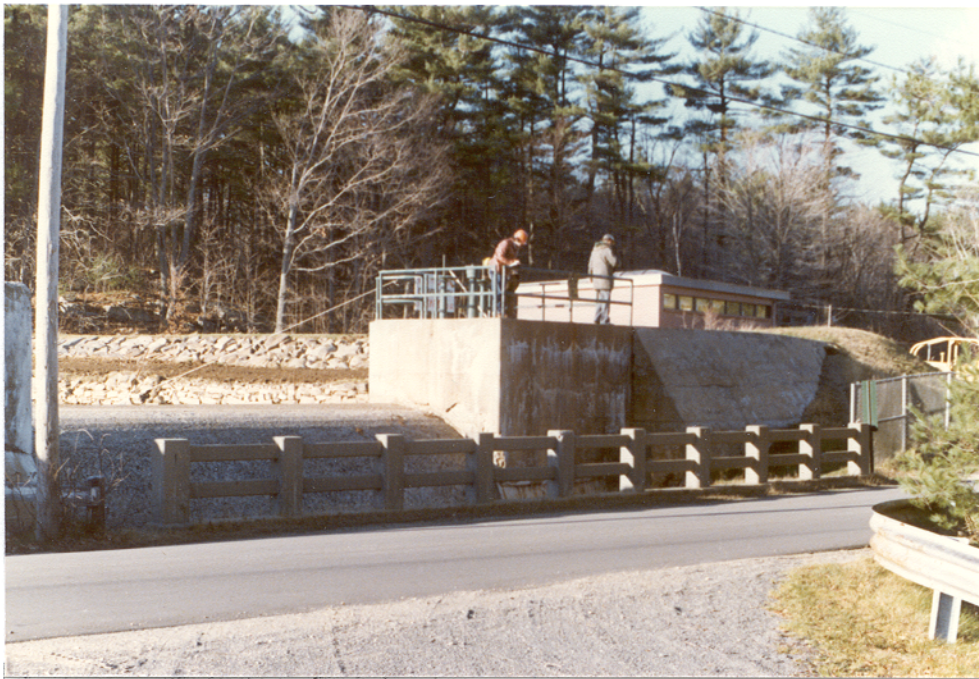
The visible portion of the gravity wall to the left of the spillway, Photo No. 9, has very pronounced surface deterioration in the lower region of the downstream face. Other portions of this wall have surface crazing, efflorescence and shrinkage cracks. The major portion of the wall's downstream side is covered by an earth fill shell with a well vegetated surface of mowed grass.

9. Spillway/gate structure and Chases Pond Road, downstream

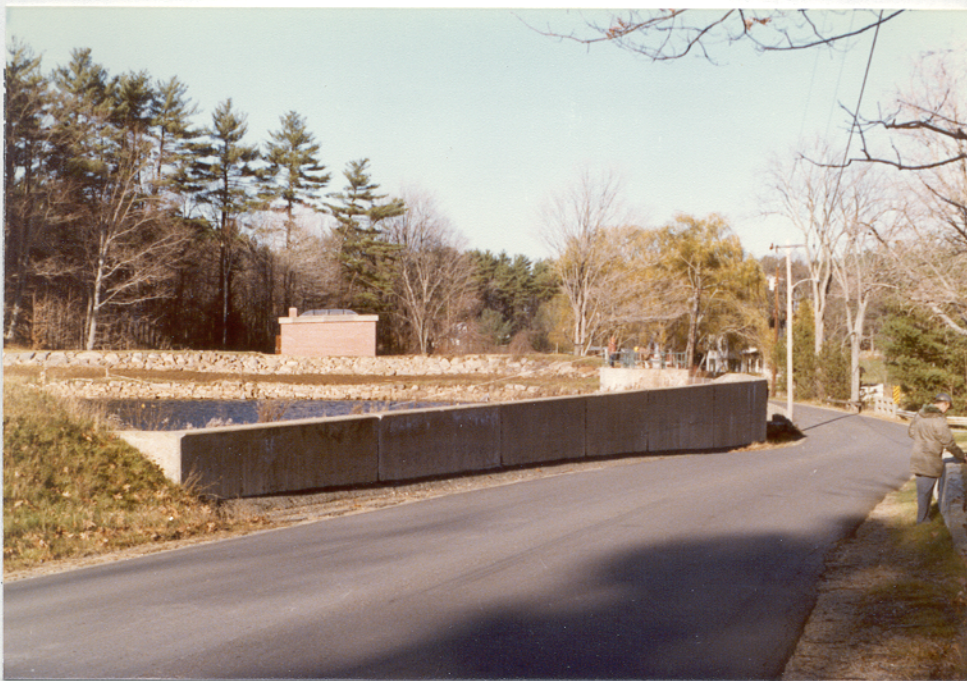
10. Cantilever wall, downstream

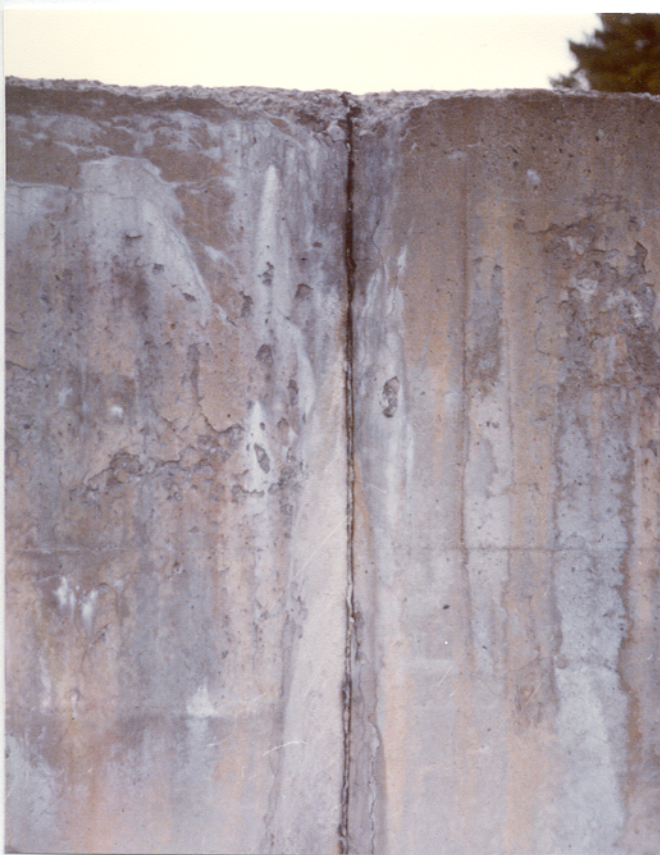
In general, the designed cross-sections of the dam indicate configurations which would be expected to have adequate factors of safety normally used for structures of comparable height with the possible exception of the one cantilever wall panel recommended for investigation in the preceding paragraphs. This particular cantilever wall panel probably has a lower factor of safety than the adjacent panels due to, 1) it has the greatest wall height, 2) it is not restrained by a return wall as in the case of the wall panel to its immediate left, 3) the footing is positioned more to the front of the wall than the other panels and 4) the foundation is at the lowest elevation of all wall panels thus probably having greater upward hydrostatic pressures on the base.

Chases Pond Dam is located in Seismic Zone 2 and in accordance with Recommended Phase I Guidelines does not warrant seismic analysis provided static stability conditions are satisfactory and conventional safety margins exist. One wall panel exhibits some movement indicating conventional safety margins may not exist. Seismic analysis of this section should be performed.

11. Tilted cantilever wall panel, downstream

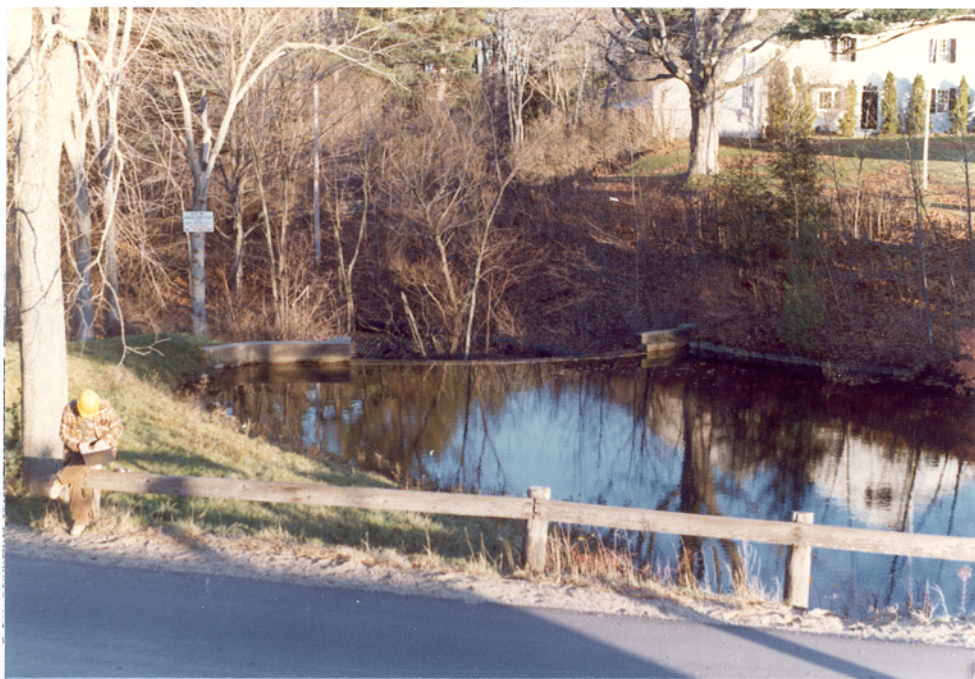
12. Little Pond and Little Pond Dam

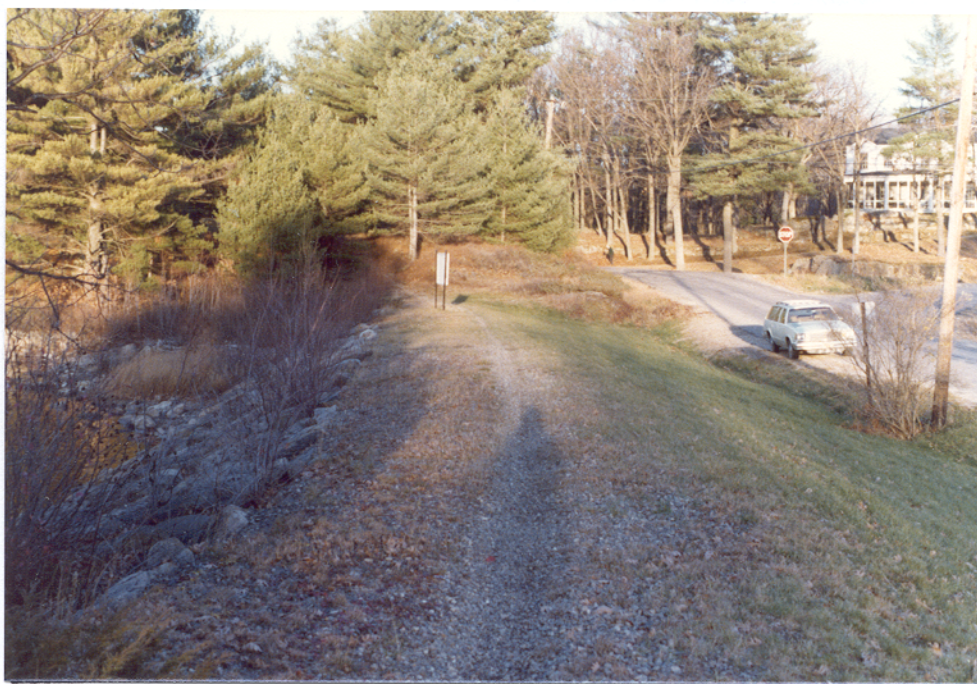
On the downstream side, the earth dike is a maximum of 6 ft. in height. The crest elevation of the dike in relation to Chases Pond Dam could not be readily verified. The condition of the dike is excellent.

13. Overview of crest, upstream and downstream sides of earth dike 1,300 ft. southwest of dam site
